Gauging the tide

A critical review of the current level of methods used to assess and manage flood risk in the Upper Severn Estuary

Advance the Line

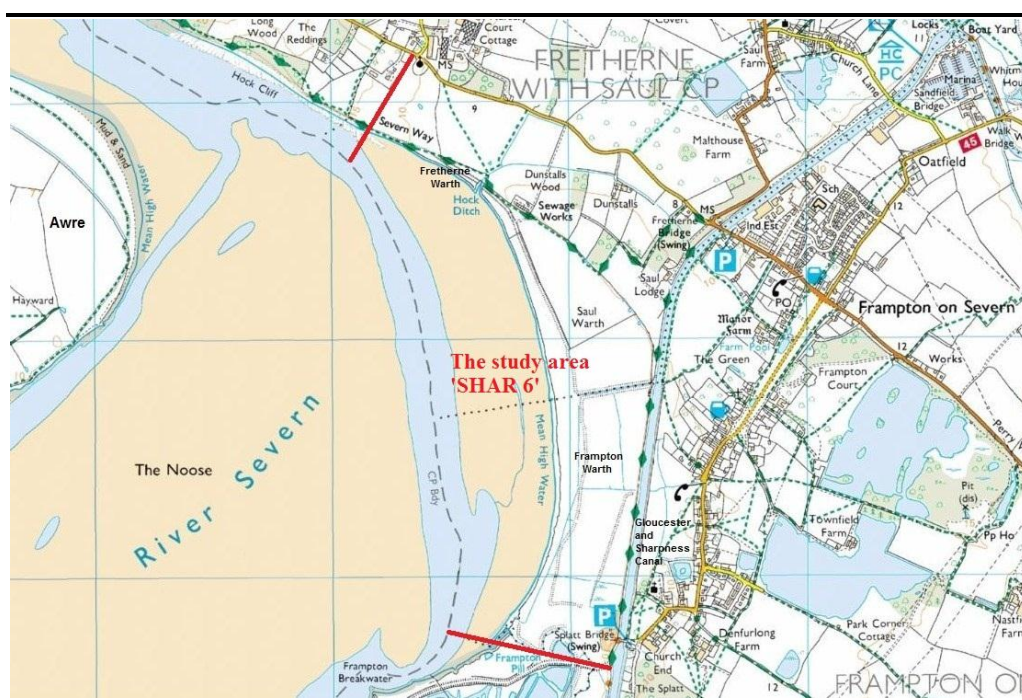
Figure 1.1 The study area

The northern section from Hock Cliff to Hock Ditch comprises a high-cliffed shoreline of lower lias clay and bands of limestone¹ which gives way to the lower-lying unstructured alluvium of Fretherne Warth on the approach to Hock Ditch. This topography continues southwards throughout the rest of the policy unit where Saul and Frampton Warths are collectively known as 'The Severn Lands'. The southern extent is marked by Frampton Pill which forms the boundary with neighbouring Slimbridge Warth.

Patterns of erosion and accretion of these reclaimed warthlands, which lie on the outside of a large meander, have been influenced by both natural processes and anthropogenic intervention. The powerful, relatively short flood tide and long ebb, which often carries additional fluvial flow, both play an important part in shaping the shoreline and the river's ephemeral mudflats and midstream sandbanks.

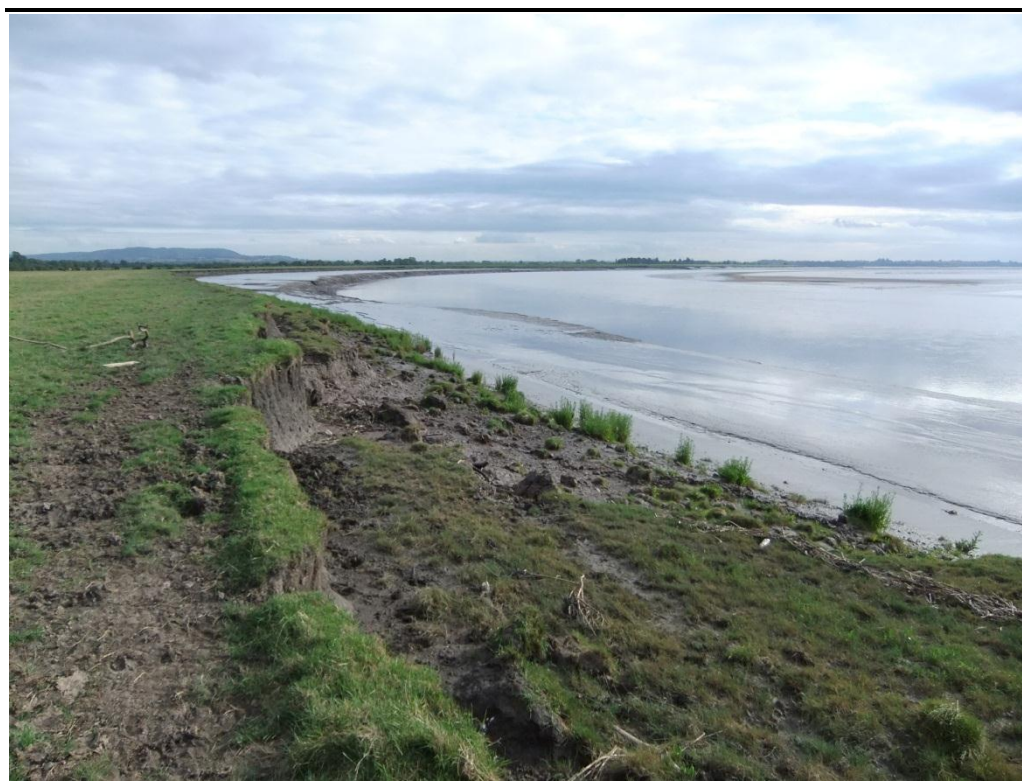
Despite the lack of firm data, there is general agreement that the last 50 years (i.e. within the lifetimes of several local amateur naturalists) have seen a dramatic decline in passerine birds (e.g. Skylarks), wildfowl (e.g. Wigeon) and mammals (e.g. Brown Hares). Whilst much of this decline is likely to be a result of wider habitat loss and changes in agricultural practice, some of the decline is also thought to be a direct result of local loss of habitat associated with the erosion on the warth itself. Paradoxically, erosion of the high saltmarsh also leads to the development of low and mid-level saltmarsh and mudflat that also have a benefit for wildlife, although given the narrow band covered by the saltmarsh, the effects are on a much smaller scale than elsewhere in the estuary.

Figure 1.3 *Narrow band of saltmarsh on Saul Warth, 8th August 2012*

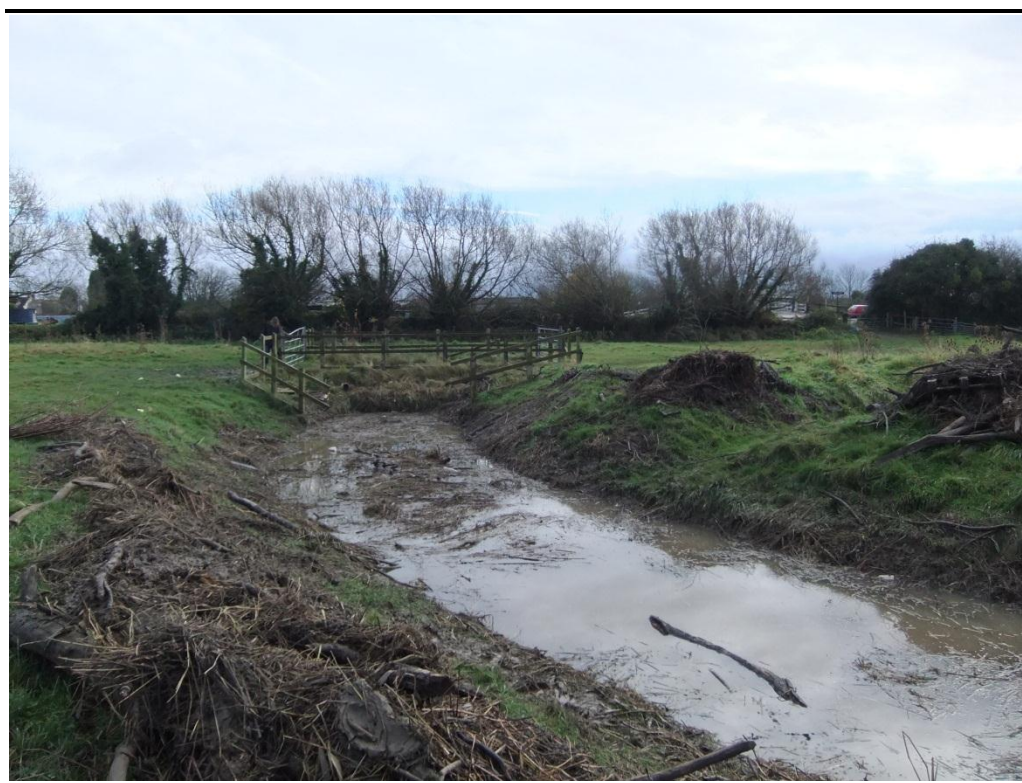
The report also considers the management of surface water inasmuch as it relates to the *SEFRMS*. Successful discharge of surface water from the villages of Fretherne-with-Saul and Frampton on Severn is inextricably linked to the mechanisms at the main outfalls of Hock Ditch and Frampton Pill (which works in conjunction with those relating to the Gloucester and Sharpness Canal).

Figure 1.4 *Frampton Pill, 17th November 2012*

The report highlights the need for these outfalls to be effectively maintained and monitored to ensure that the management of pluvial, fluvial and tidal dynamics are integrated.

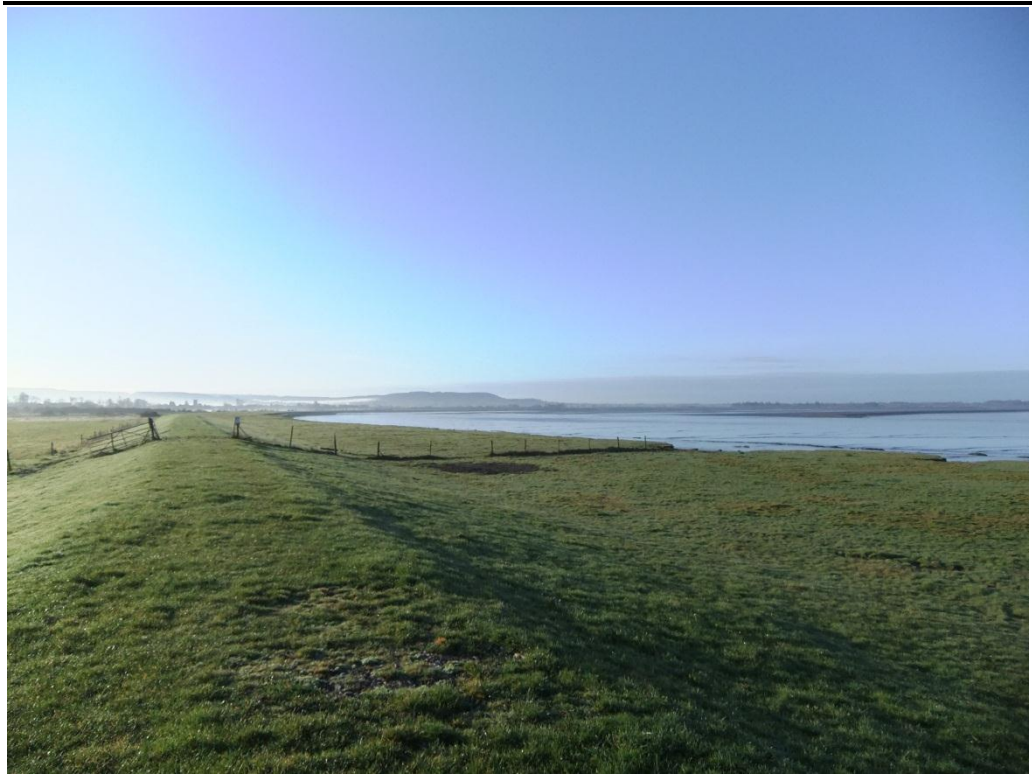
Figure 2.1 *The Environment Agency's embankment on Saul Warth is kept clear to aid inspection and discourage mammals and vegetation from weakening the defences, 25th February 2012*

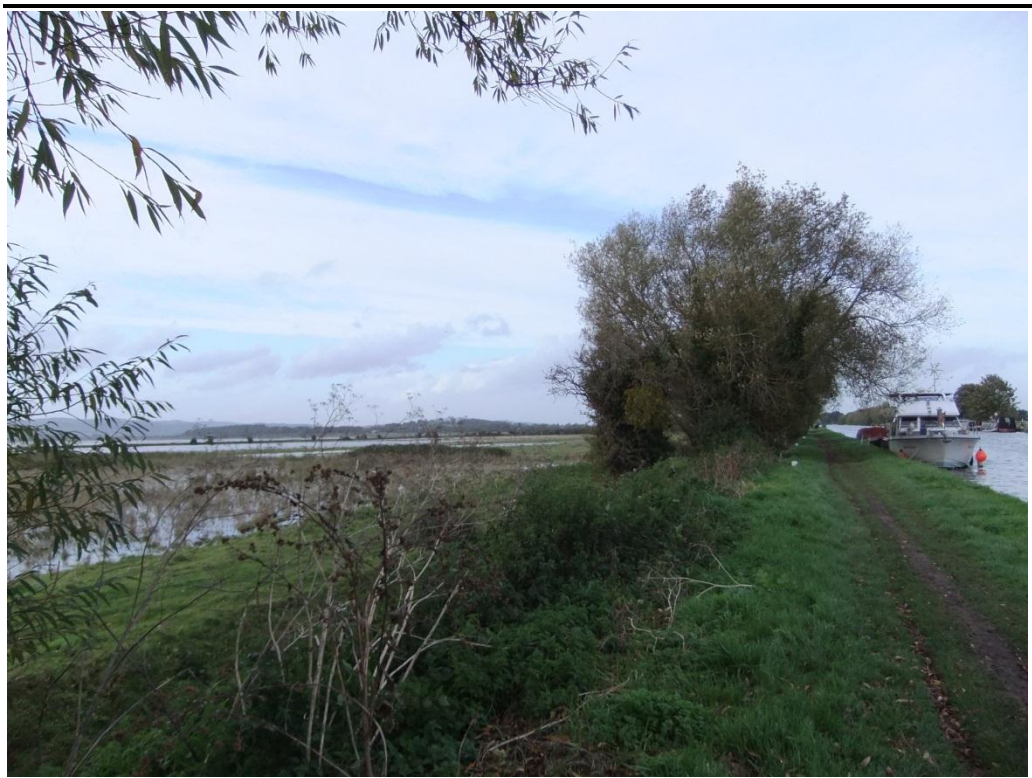
Figure 2.2 *The overgrown western canal bank at Frampton, 17th October 2012*

Given that the canal bank is almost 200 years old, and that it has only been subject to a visual inspection (which must have been hampered by undergrowth), it is difficult to make any estimate of its suitability as a primary flood defence.

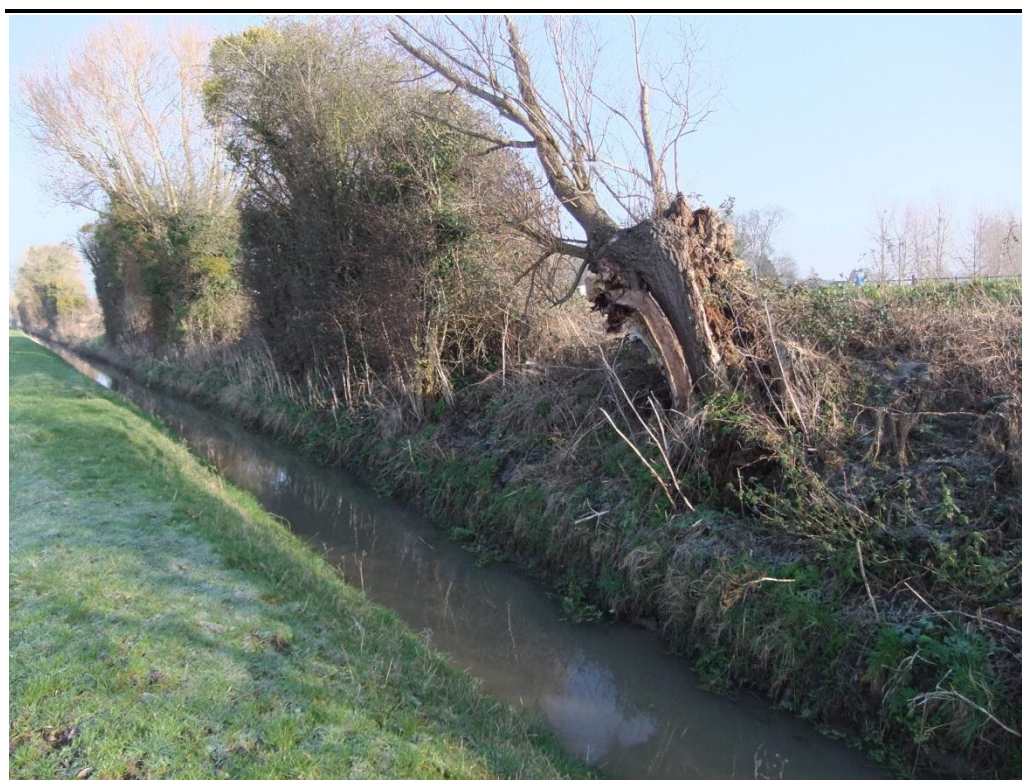
In defining the canal bank as a primary flood defence, no mention has been made of the fact that a primary drainage channel runs at the foot of its western bank. This ditch is owned by the CRT and maintained under contract by the LSIDB, yet no mention of this is made in the *SEFRMS*, nor is it apparent that any discussions have taken place with the LSIDB on the impact of the *SEFRMS*.

Figure 2.3 ***The primary drainage channel beside the western canal bank at Frampton, 13th January 2013***

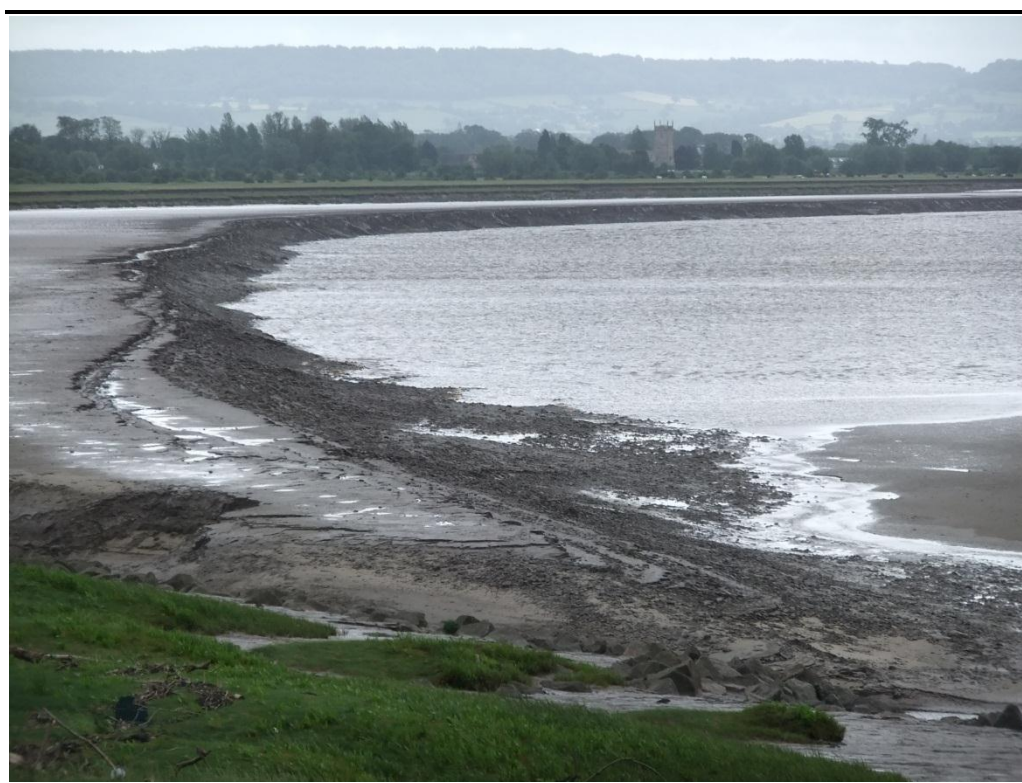
The SMP2 ambiguously states: *'The mud bank adjacent to Frampton has either eroded or remained relatively stable.'*

Figure 2.4 *The ephemeral high-cliffed mudflat adjacent to Saul and Frampton Warths in a phase of rapid erosion, 23rd June 2012*

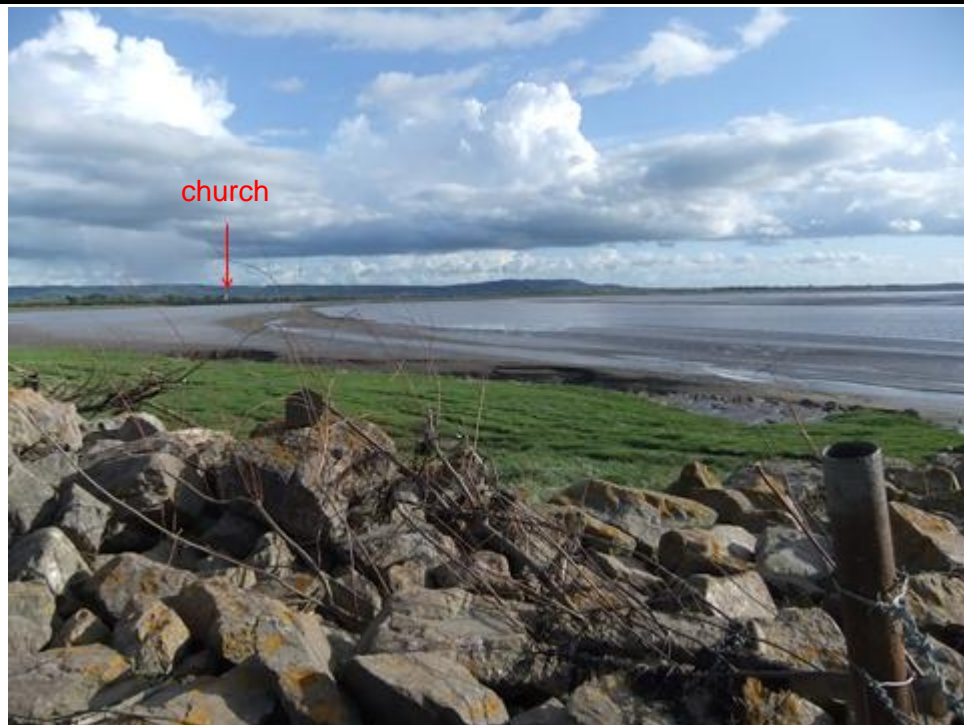
Figure 3.2 *Mudflat looking from Fretherne Warth, 10th April 2012*

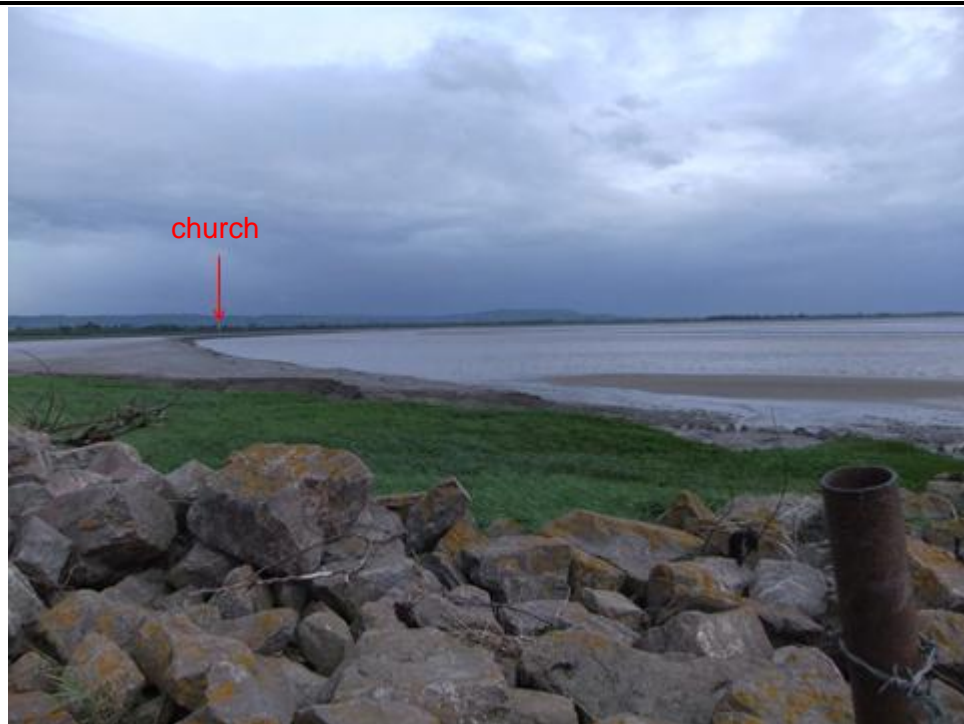
Figure 3.3 *Mudflat from the same position immediately after the storm, 8th June 2012*

The present positions of the main channel hard against the eastern river bank, and that of the remaining mudflat, appears to mirror those of the 1970s. Air photographs from the Cambridge University Collection of 1973 and 1977¹ are particularly helpful and give a good indication of the amount of erosion that the warths might expect during the next few years having now lost their cover.

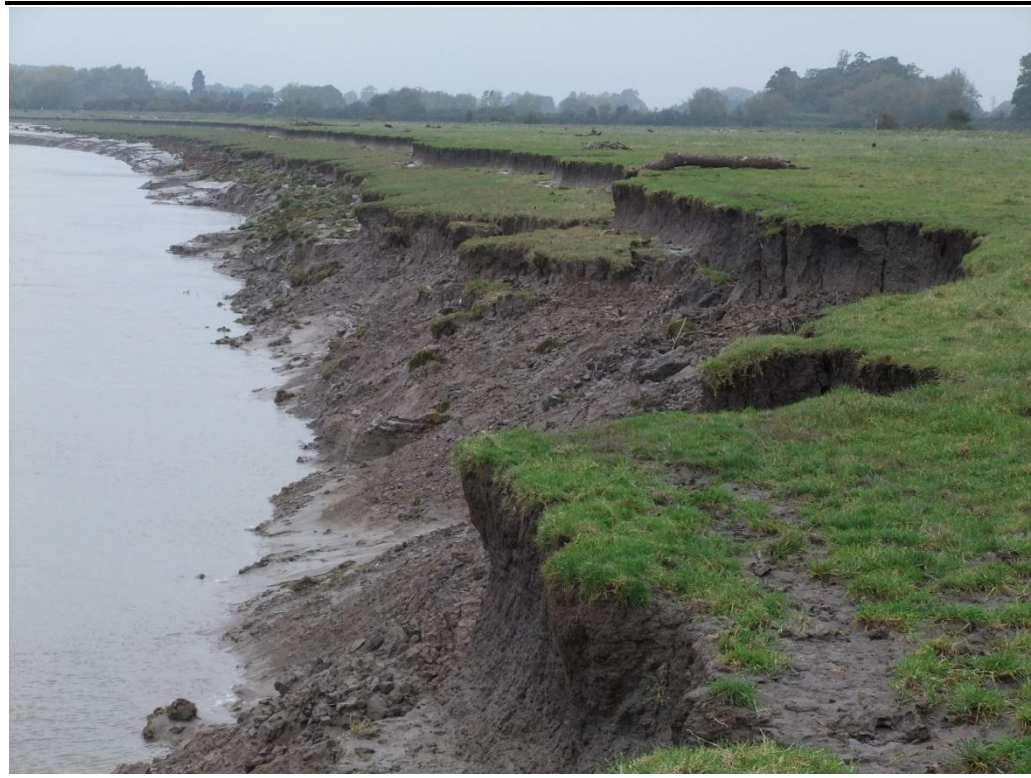
almost impossibly narrow band which is not replicated anywhere else within the estuary.¹ As a consequence it has generally been erroneously thought that the different ground levels within this band have indicated previous extents of erosion.

Figure 3.4 *Narrow band of saltmarsh on Saul Warth, 24th October 2012*

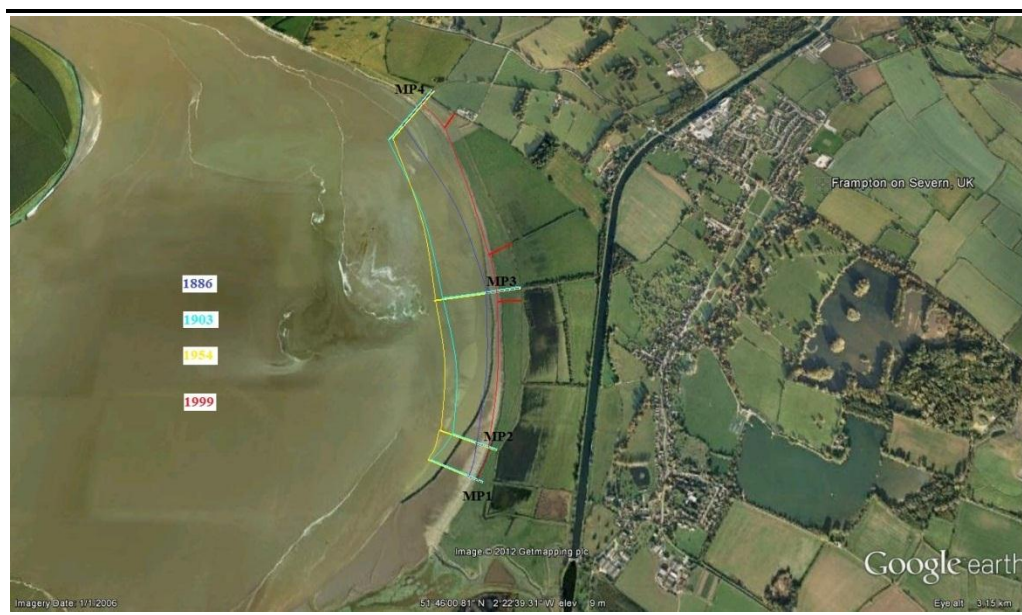
Figure 3.5 **Monitoring Point locations**

A description of the MPs and their locations (National Grid Reference) is provided in Appendix C.

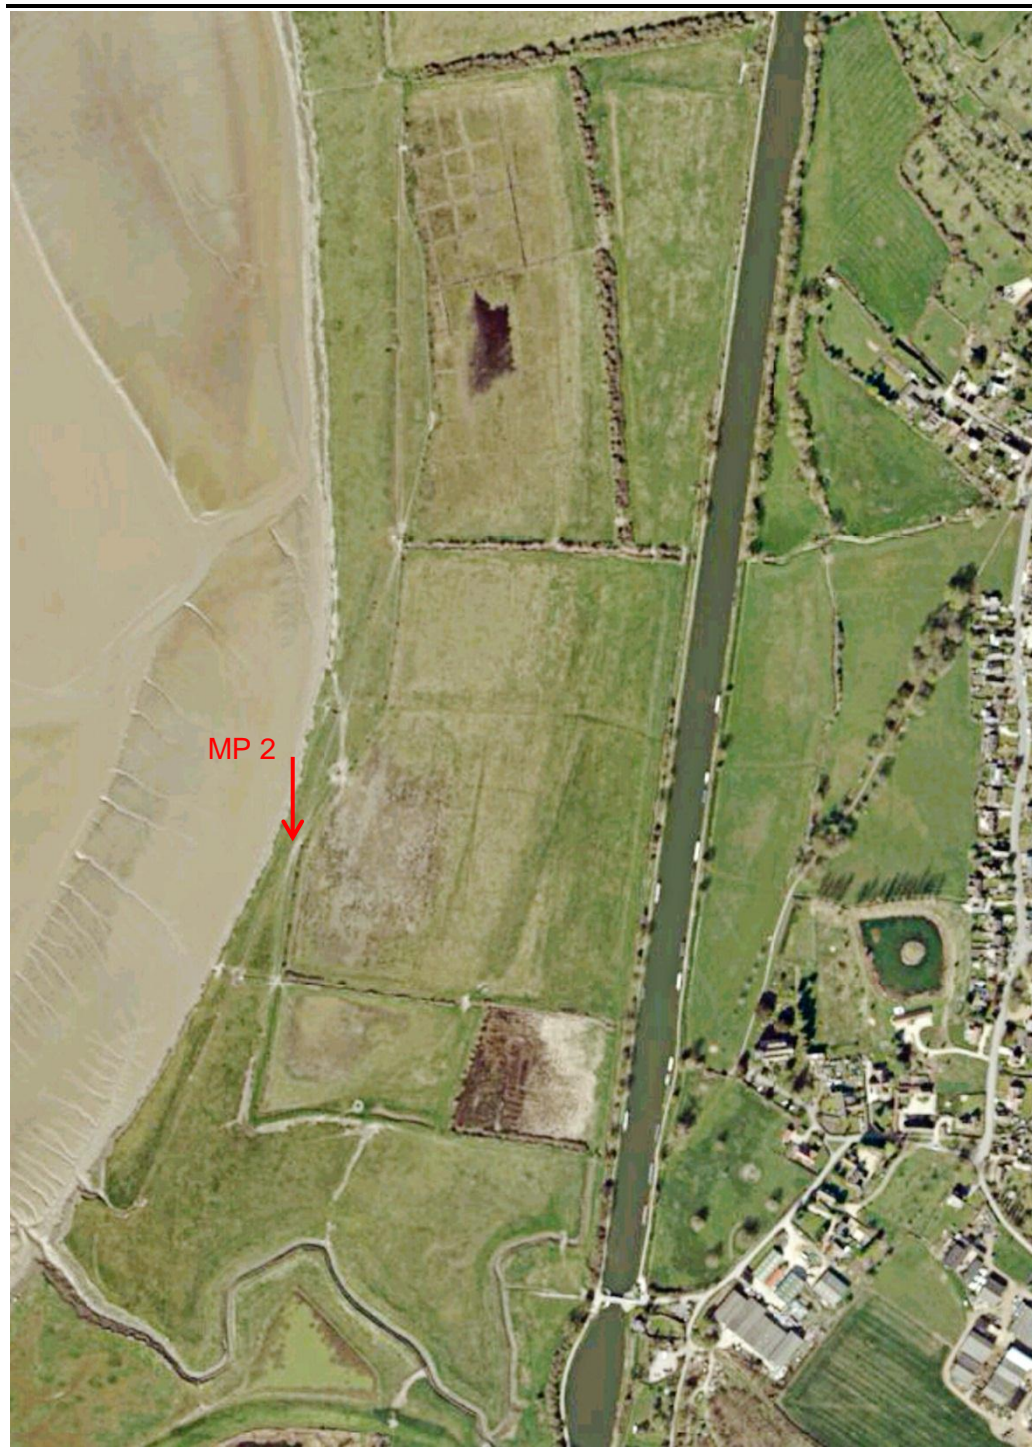
Figure 3.8 *Frampton Warth, July 2011¹*

Measurements taken on site in November 2011 and November 2012 give rise for concern, particularly at MP 2 which is only 4.00 m away from a large breach in the old sea wall and interestingly the area most at risk during the erosion cycle of the mid-19th century. At this point the outer warth (currently 12.90 m in width)² is eroding at more than 2.00 m per annum. A few metres north of MP 2 the outer warth is just 10.40 m wide.

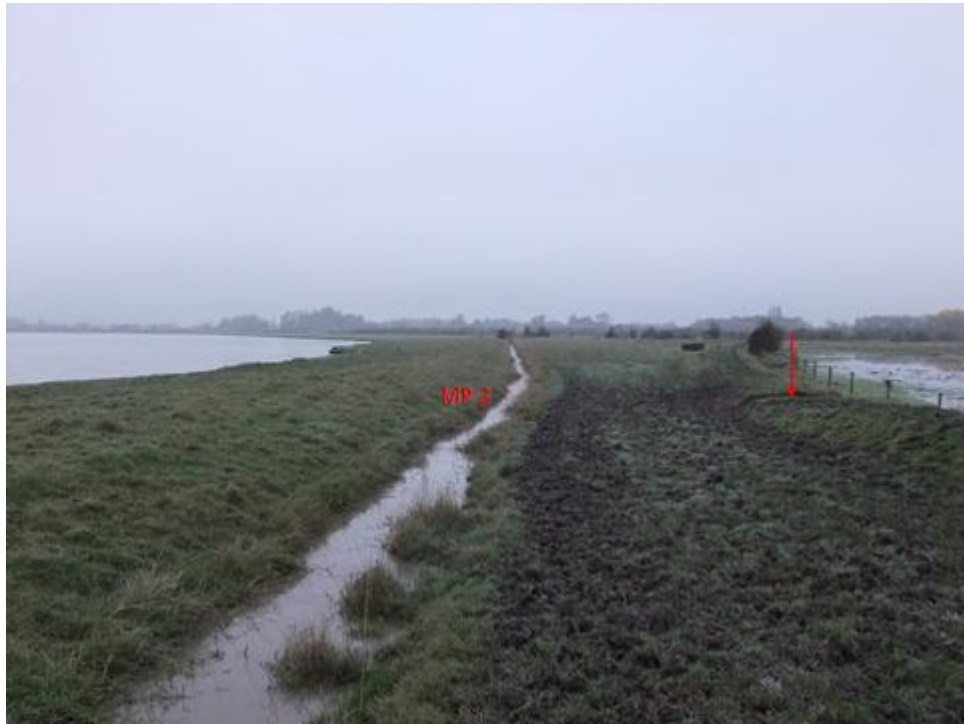
Figure 3.9 *Monitoring Point 2 at high tide, 15th November 2012 (arrow marks the breach in the old sea wall).*

The height of the outer warth increases over time as layers of silt are deposited by the tides. At MP 2 the outer warth is 8.75 m AOD, some 0.75 m above Great Narles, the adjacent field between the old sea wall and the Gloucester and Sharpness Canal. The study undertaken in 2010 by WWT Consulting incorporates a LiDAR survey (see Figure 7.1) which illustrates that a water level of 8.25 m AOD would flood much of the site if there was open connection with the river. Based on the current pattern of erosion this could happen within the next 5-10 years.

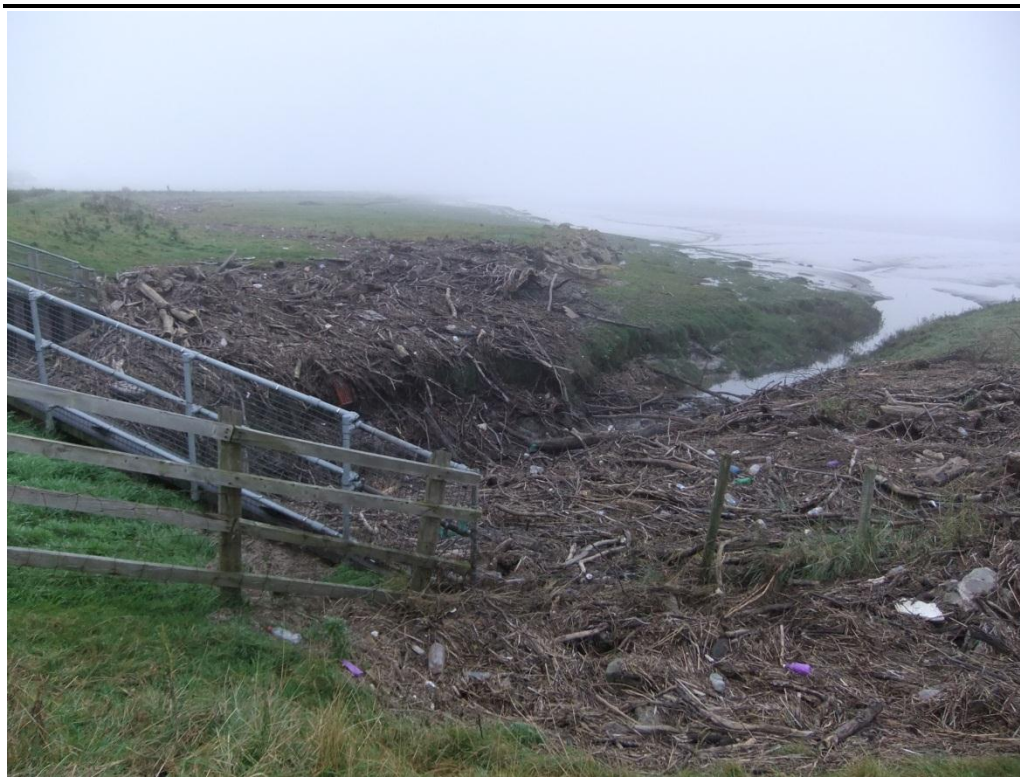
Figure 5.1 *Hock Ditch outfall, 21st October 2012 with wrack from recent high tides*

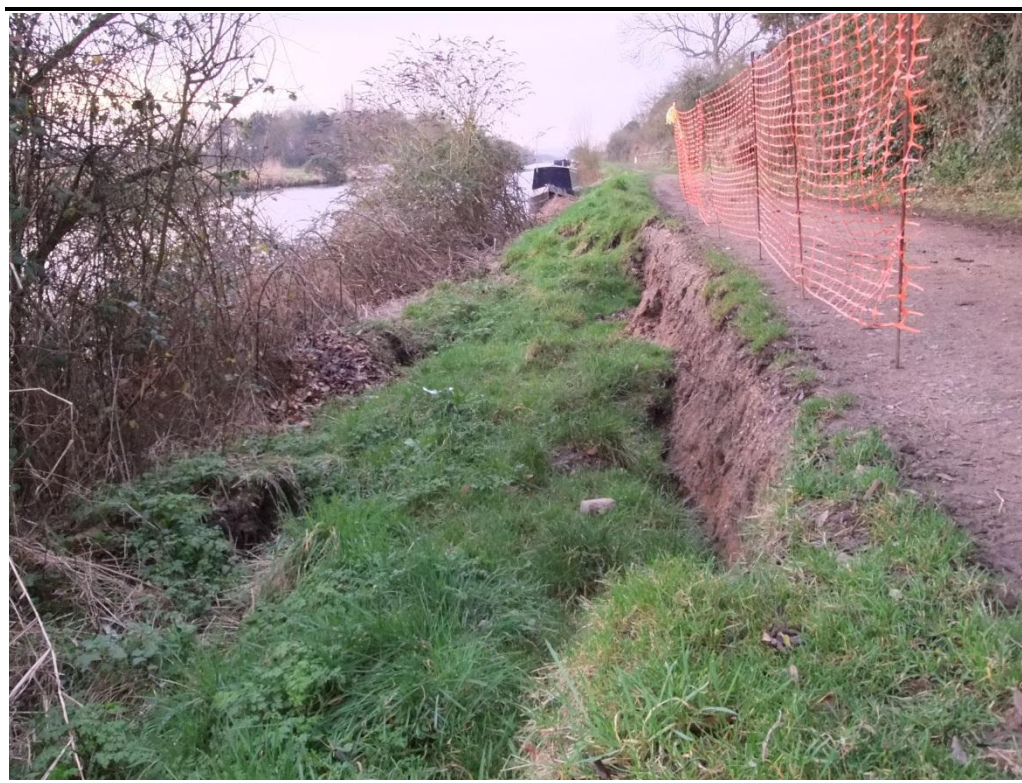
embankments, has led to a number of failures along the canal banks where the integrity of the sheet piling and waling beams have been compromised under the load exerted.

Figure 6.1 *Canal bank slippage near Saul Lodge, Fretherne, 8th January 2013*

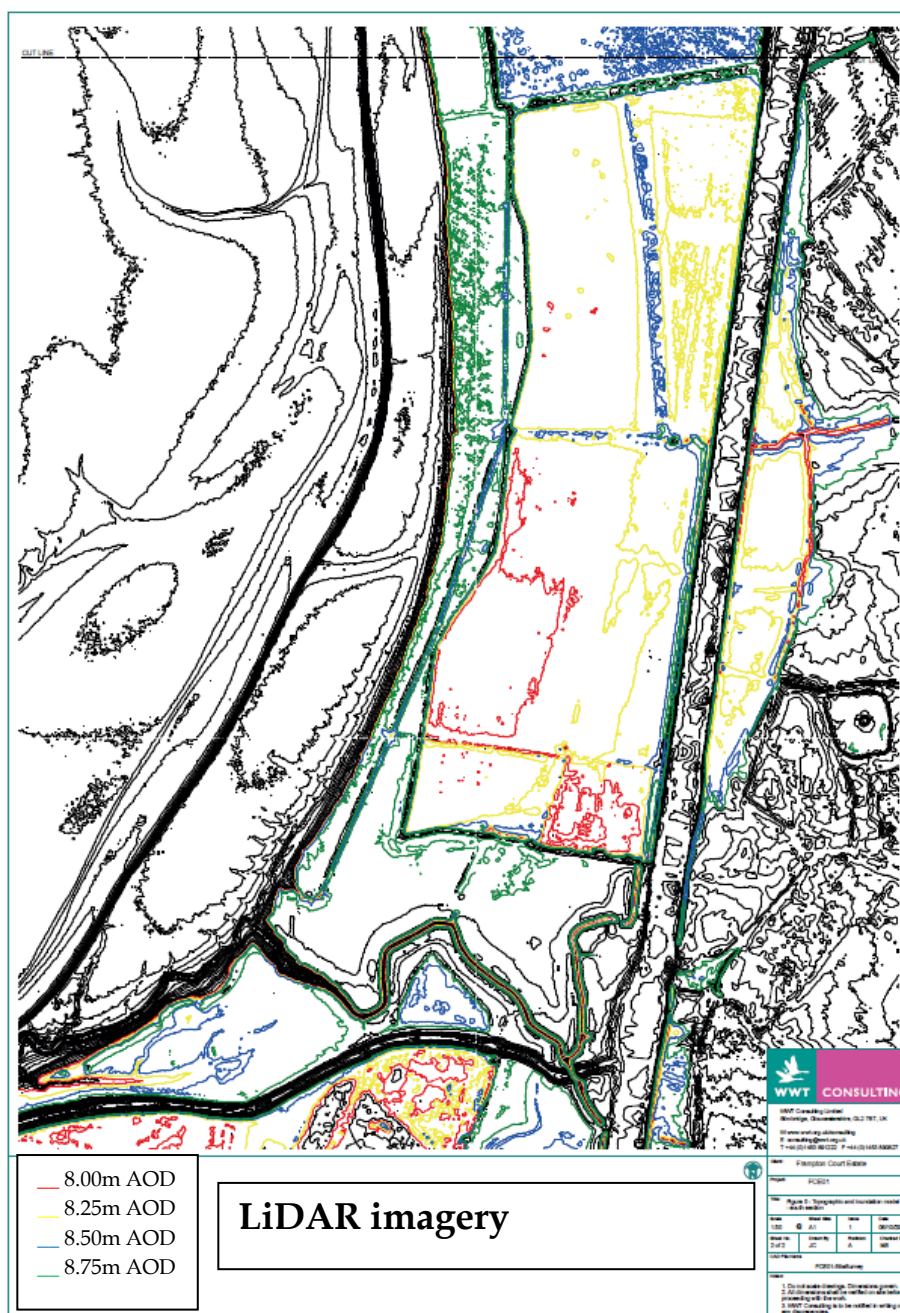
Figure 7.1 LiDAR data for Frampton Warth

The LiDAR data supplied within the WWT Consulting study is of particular interest as it provides the most accurate indication available of the extent of likely tidal inundation. The southern half of the site is represented in Figure 7.1 which clearly shows the difference in height between the narrow outer warth (8.75 m AOD) and the adjoining low-lying field (variously 8.00 m and 8.25 m AOD).

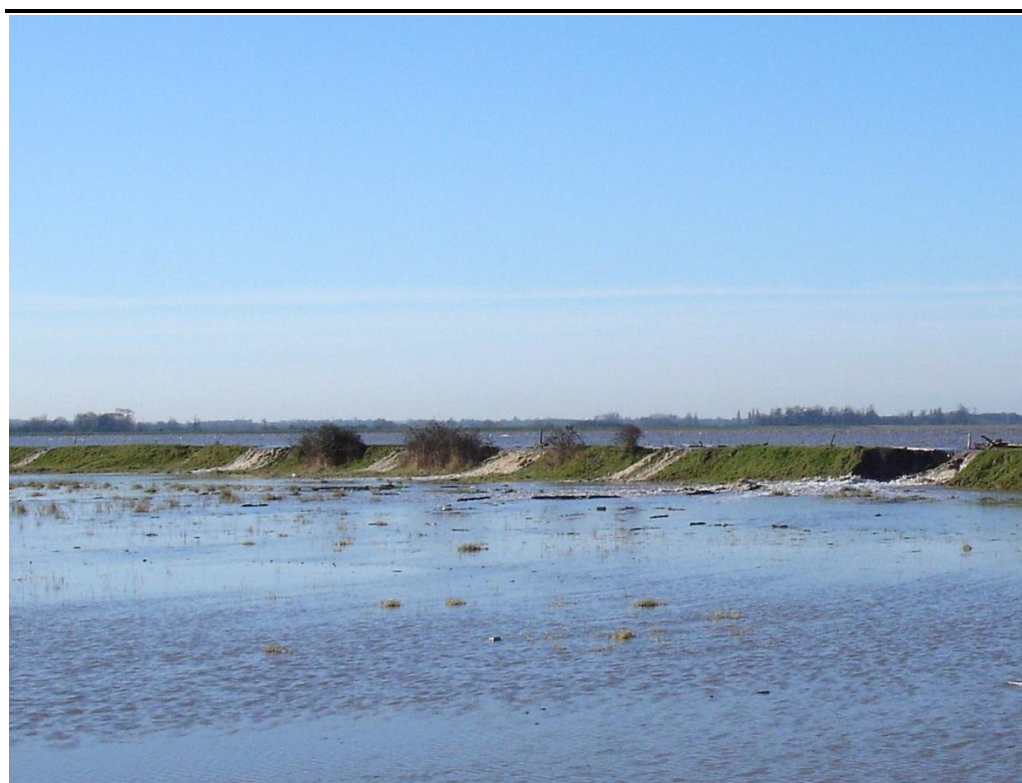
Tide tables are a guide only. The actual height of the tide is increased by, amongst other things, low barometric pressure and a west or south-westerly wind. At present all tides over 9.00 m are considered to have the potential to top the outer warth given these conditions.¹ Conversely under high barometric pressure and still conditions a 10.00 m tide may currently stay just within the river banks.

Figure 7.2 *Tide topping and breaching the abandoned sea wall on Frampton Warth, 2nd March 2006*

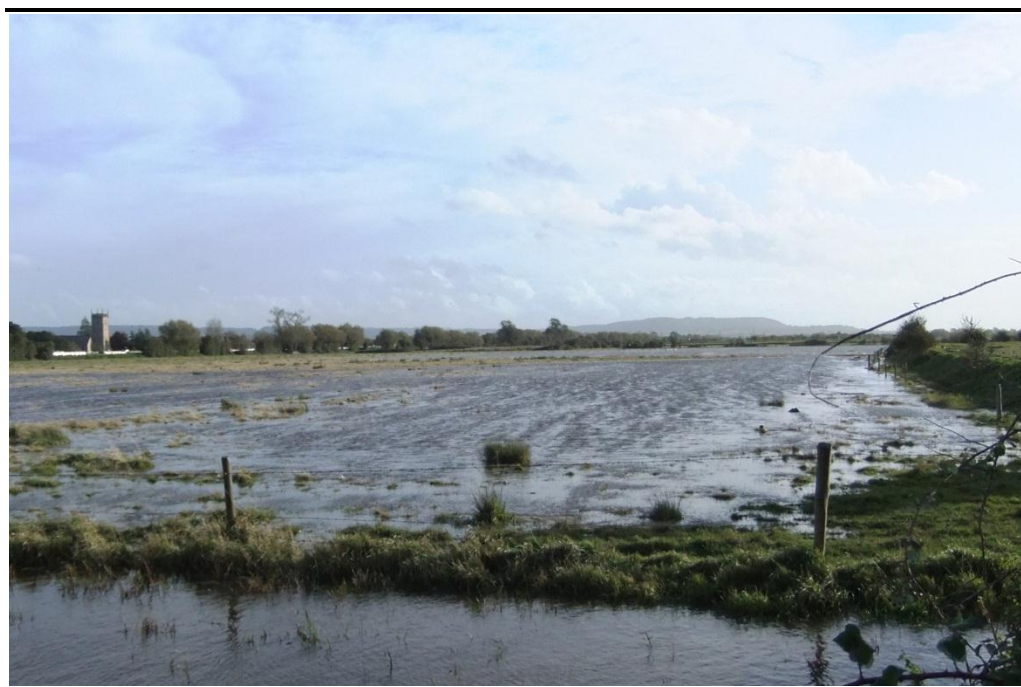
Figure 7.3 **Extent of inundation 6 hours after high tide, 17th October 2012**
